FINAL REPORT

FHWA-WY-97/01F

MITIGATION OF ROADWAY SETTLEMENT ABOVE BURIED CULVERTS AND PIPES

**Department of Civil and Architectural Engineering
University of Wyoming
P.O. Box 3295 University Station
Laramie, WY 82071-3295**

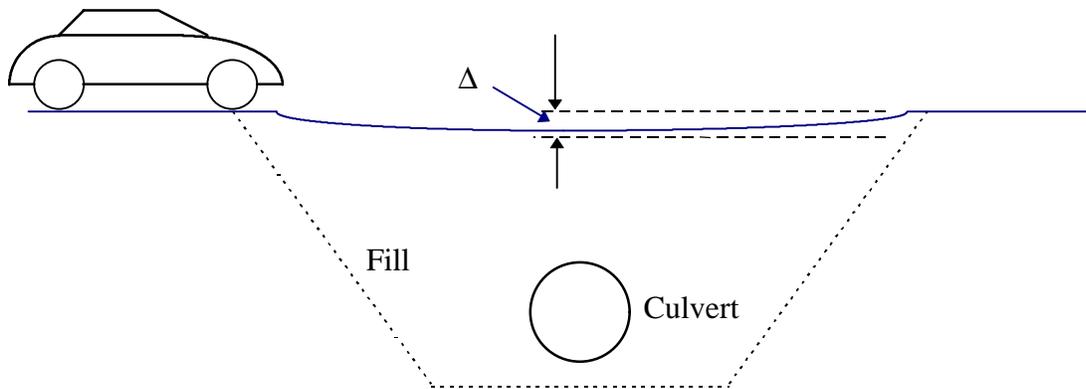
Installation of culverts, water lines, stock passes, and other similar structures across roadways typically involves excavation of existing ground followed by placement of the structure, backfilling of the excavation with compacted soil, and construction of a pavement over the backfill. If vertical deformation occurs in the soil or rock beneath the structure, in the backfill material, or in the structure itself, it is likely to be manifested as vertical deformation, or settlement, at the surface of the roadway. The result of roadway settlement may be relatively minor and practically unnoticeable by motorists, or it may cause a significant "dip" in the roadway, posing a safety hazard and possibly vehicular damage. In extreme cases, settlement may result in cracking and premature deterioration of the pavement, requiring an overlay or pavement replacement. Figure 1 depicts the general nature of the problem. Delta (Δ) as seen in Figure 1 is the maximum deflection due to settlement.

Figure 1. Roadway Settlement Over Culvert

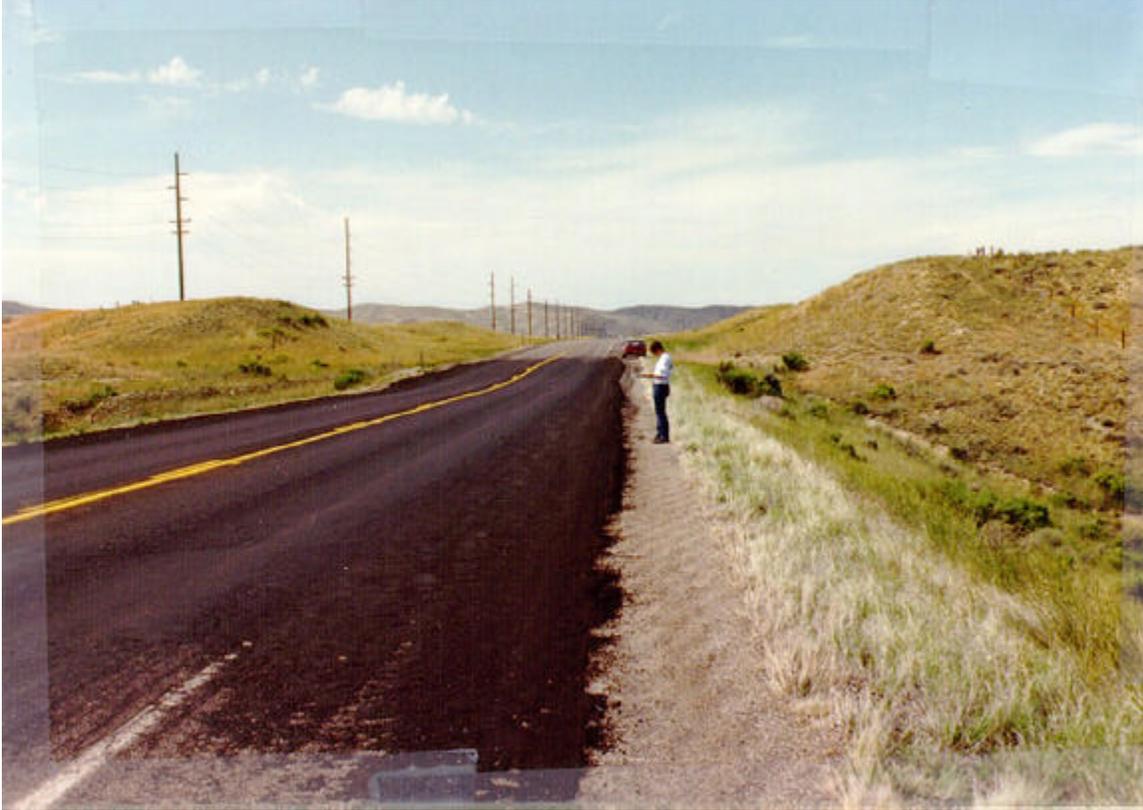
The project team visited each of the twelve selected sites to make detailed inspections. Items which were inspected and documented included culvert type, size, and location, evidence of ground movement, damage to culverts and pipes such as buckling and excessive deflections, field identification of subgrade and backfill soils, description of drainage facilities, possible sources of water to the subgrade and backfill soils, approximate magnitude of roadway settlement, and the extent of pavement damage, if any. A typical culvert site showing roadway damage is shown in Figure 6.

Figure 6. Photo of Investigated Site Illustrating Roadway Settlement and Recently Placed Cold Mix

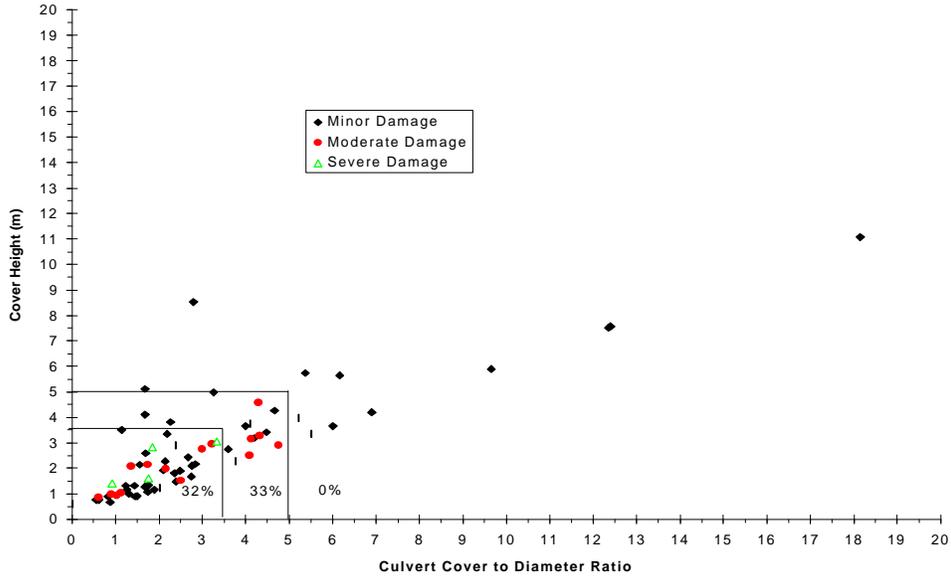
It was observed that the four sites exhibiting severe settlement are located in relatively shallow fills. The heights of fill covering the culverts were 3.0, 2.8, 1.4, and 1.6 meters, respectively. The ratios of fill height to culvert diameter for these sites are 3.3, 1.9, 0.9, and 1.8, respectively. Sites exhibiting moderate damage also have relatively low cover. Sites showing only minor settlement in general had greater depths of cover and higher ratios of cover to culvert diameter.

Figure 7. Cover Height versus Cover Ratio, Shirley Basin
