FINAL REPORT

FHWA-WY-97/01F

MITIGATION OF ROADWAY SETTLEMENT ABOVE BURIED CULVERTS AND PIPES

**Department of Civil and Architectural Engineering
University of Wyoming
P.O. Box 3295 University Station
Laramie, WY 82071-3295**

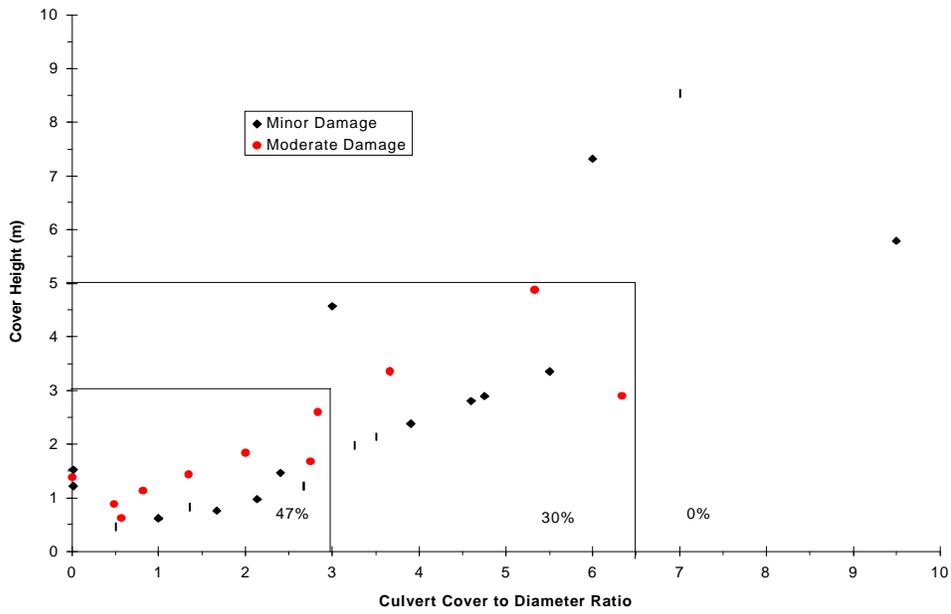
Figure 8. Cover Height versus Cover Ratio, Baggs-Encampment

Figure 8 and Figure 9 show similar graphs for WYO 70 between Baggs and Encampment (Figure 8) and Pine Haven Road (Figure 9). In each case, only minor or no damage was observed for cover heights over 3.5 to 5 m and for cover ratios over 3 to 6.5. Figure 10 shows a similar plot for the sites in District 5. The data collected in District 5 differs from the other three in that only locations reported as being problems were investigated, while other culvert sites on the same projects were not inspected. Therefore it was not possible to determine the percentage of sites with moderate or severe damage for a given cover height or cover ratio. District 5 includes several sites at which severe and moderate damage was observed even though cover heights and cover ratios were relatively high.

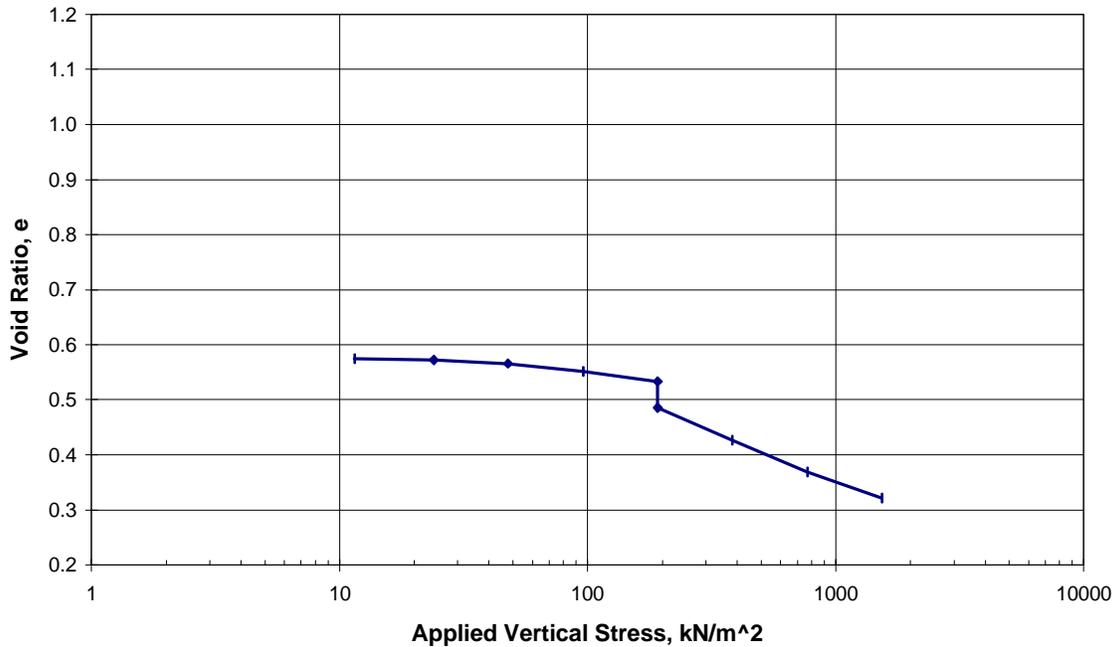
Figure 16. Typical Results From Collapse Index Tests

Additional testing that was performed on the soil samples obtained from the drilling program (see Chapter 3 *Field Investigation of Roadway Settlement*) were collapse index tests as described in Chapter 4 *Laboratory Testing Program*. Figure 16 is a plot of the void ratio versus applied vertical stress. The void ratio experiences a sudden decrease, or collapse, when the specimen is wetted at the applied vertical stress of 200 kN/m². This illustrates typical results obtained from the collapse index tests. However, some of the collapse index tests had the opposite result, in which the void ratio experienced a sudden increase, or swelling, when wetted. A complete set of plots showing results of all collapse index tests is given as Appendix D in the thesis by Lundvall (1997).

During this study, not all of the specimens exhibited collapse. When inundated with water, several specimens swelled. As noted by Lawton et al. (1992), swelling can predominate over collapse even at overburden pressures as great as 1,600 kN/m² for soils with high expansive clay contents. For these specimens, the categories for the classification of the collapse index (or swell index) were simply reversed to indicate the degree of swelling. Table 18 gives a summary of the specimens tested, the percent of collapse or swelling, and the classification of the specimens according to the categories given.
